NO: SD-SC-004

SAFETY DIRECTIVE -MANDATORY-

MODEL AFFECTED: SPORTCRUISER

SUBJECT: FASTON ELECTRICAL CONNECTOR – REPLACEMENT OF

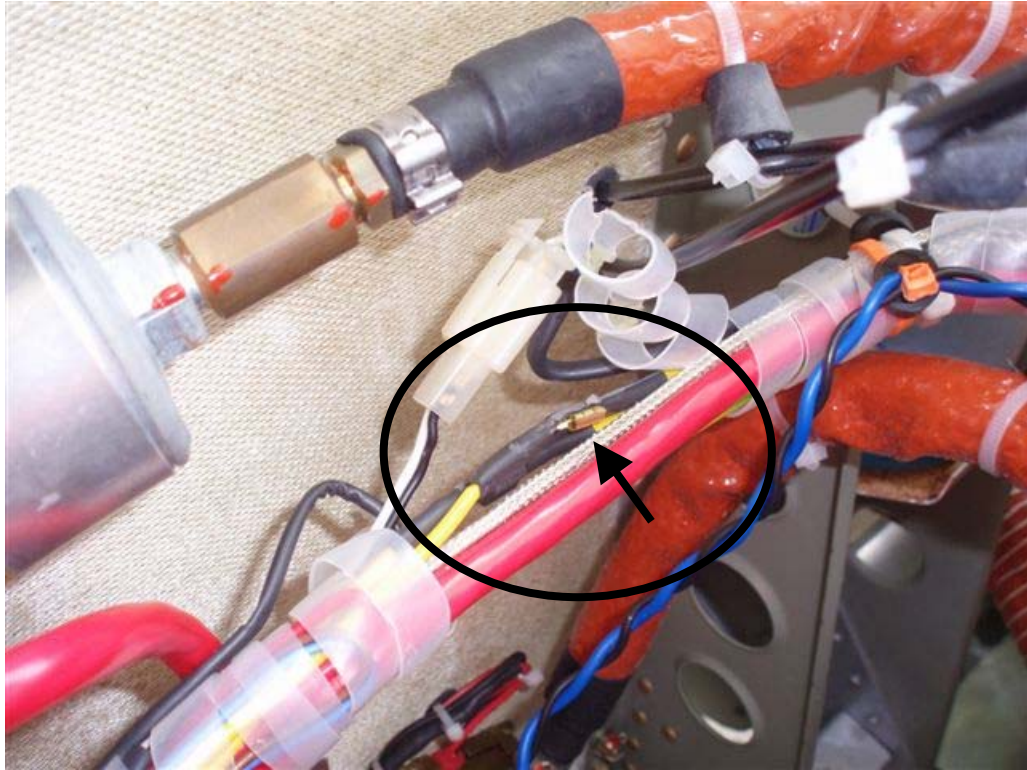
Fig. 1

There were some cases in operation when due to the big transition resistance in the connector the abnormal connection heating and burn-out the connection insulation tubing was caused. (see Fig. 1) It is needed to replace this Faston connector by soldered connection.

1. Remove heat shrinkable tubing.
2. Cut wire close to Faston tab and Faston receptacle.
3. Prepare wire for soldering, use a solvent for cleaning.
4. Use 100 mm long wire, the same grade, yellow color, 2.5 mm², for bridging of cutted faston connector. Prepare it for soldering, use a solvent for cleaning.
5. Put on heat shrinkable tubing to wire.
6. Solder wire using by means of soldering iron.
7. Move heat shrinkable tubing to the soldered area, use heat gun for shrink.
8. Restore aircraft to the airworthy condition.
9. Conduct engine test run including ignition check.
10. Annotate aircraft records to reflect compliance with this bulletin.
