CZECH SPORT AIRCRAFT	<h2 style="margin: 0;">SAFETY ALERT / SAFETY DIRECTIVE</h2>	Czech Sport Aircraft a.s. Na Záhonech 212, 686 04 Kunovice Czech Republic office@czechsportaircraft.com
No. SA-SC-008		Rev.: -
Date: 2017-12-20		Date: -
Page: 1 of 6

MODEL AFFECTED:	SportCruiser / PiperSport
SUBJECT:	Inspection and/or replacement of oil filter of ROTAX Engine Type 912 S2 / 912 ULS2
AIRCRAFT AFFECTED:	<ul style="list-style-type: none"> - SportCruiser aircraft S/N C0616, C0617, C0618. - All other aircraft the engine of which has been equipped with the oil filter part no.825016 (with a production date code from 10/17 up to 38/17) during the engine repair, maintenance or general overhaul within the period as of 08 June 2017 till 31 October 2017 inclusive and which have no green mark, see Fig.1. - All oil filters part no.825016 sold as a spare part during the period from 08 June 2017 till 31 October 2017 inclusive, with a production date code from 10/17 up to 38/17.
COMPLIANCE:	<ul style="list-style-type: none"> - Immediately on engines / spare parts not yet installed on the aircraft; - Before the initial installation on an aircraft and/or before the initial start-up thereafter; - Before t

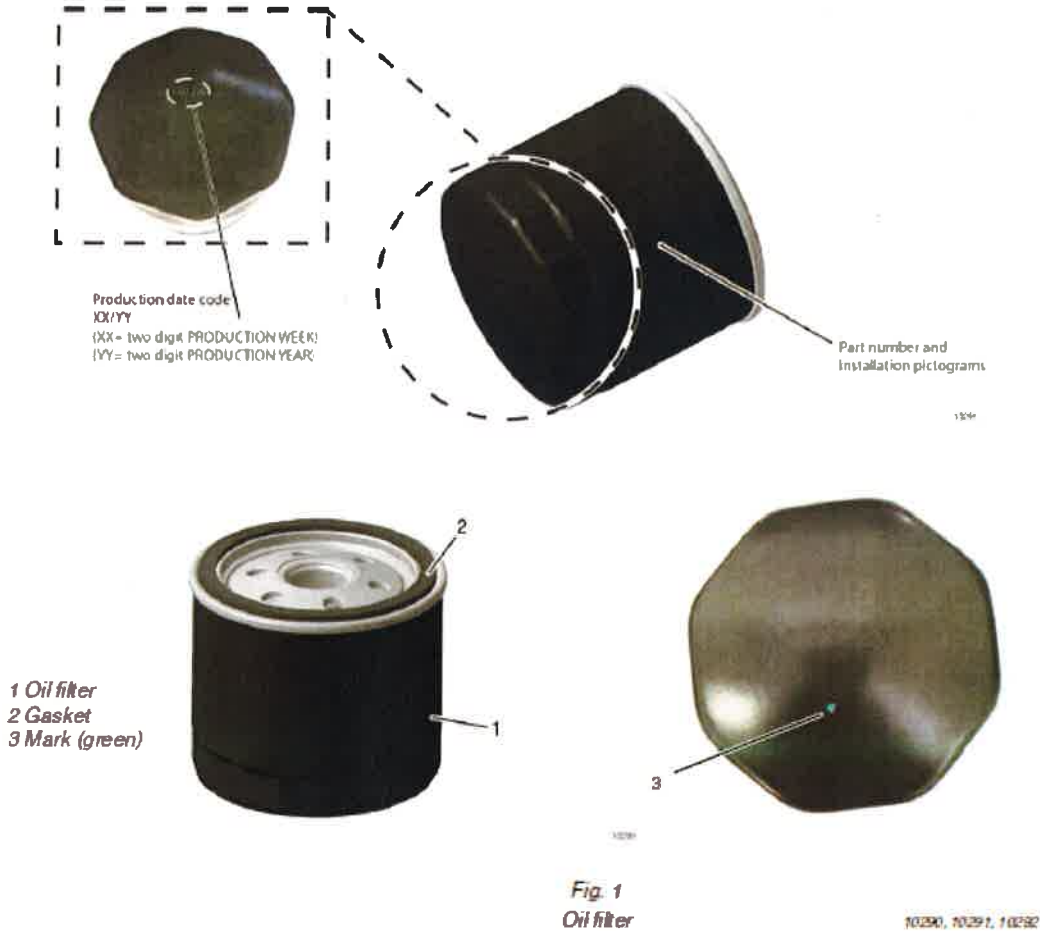
Fig.1

Due to deviations in the manufacturing process of the oil filter gasket, cracks in the gasket may have occurred. In rare cases, these deficiencies might lead to oil leakage in the area of the oil filter gasket.

As outlined above only oil filters part no. 825016 with production date code from 10/17 to 38/17 are affected, see the section *Aircraft Affected* above.

Step	Procedure
1	Check the engine logbook and maintenance documentation or shipping documents to see if this Service Bulletin has already been accomplished.
2	<p>Check whether the affected oil filter shows a green mark on the crown of oil filter (as illustrated in Fig. 1) (same area as production date code).</p> <ul style="list-style-type: none"> - green mark is present: this oil filter is OK as it has already been tested by the supplier and can be used even though the production date code is from 10/17 to 38/17. No further actions are required. - green mark NOT present: this oil filter is NOT OK, please follow the instructions in section <i>Replacement of NOT OK oil filter ...</i> <p>NOTE: If production date code is not easy to read, use a proper means of light (e.g. flashlight directed at a proper angle onto the oil filter crown etc.) for better visibility of the coding imprint.</p>

1.4 Replacement of NOT OK oil filter (installed on the respective Rotax engine)

Step	Procedure
1	Remove the affected oil filter according to the Maintenance Manual Line.
2	Install the new oil filter according to the Maintenance Manual Line.

Step	Procedure
1	Quarantine and/or remove affected filters from your inventory. Mark as unserviceable and return F.O.B. to your ROTAX [®] Authorized Distributor or their independent Service Centers.
