Czech Sport Aircraft a.s.	SERVICE BULLETIN	Czech Sport Aircraft a.s. Na Záhonech 1177/212, 686 04 Kunovice Czech Republic office@czechsportaircraft.com
No. SB-CR-016		Rev.: 6
Date: 2013-10-09		
Page: 1 of 4		Date: 2015-08-31

MODEL AFFECTED:	SportCruiser, PiperSport, PS-28 Cruiser with the NLG SG0270N
SUBJECT:	Inspection of the nose landing gear leg and its replacement (if required)
AIRCRAFT AFFECTED:	All SportCruiser aircraft with the NLG SG0270N installed All PiperSport aircraft with the NLG SG0270N installed All PS-28 Cruiser aircraft with the NLG SG0270N installed
COMPLIANCE:	Before next flight after issue of this bulletin.

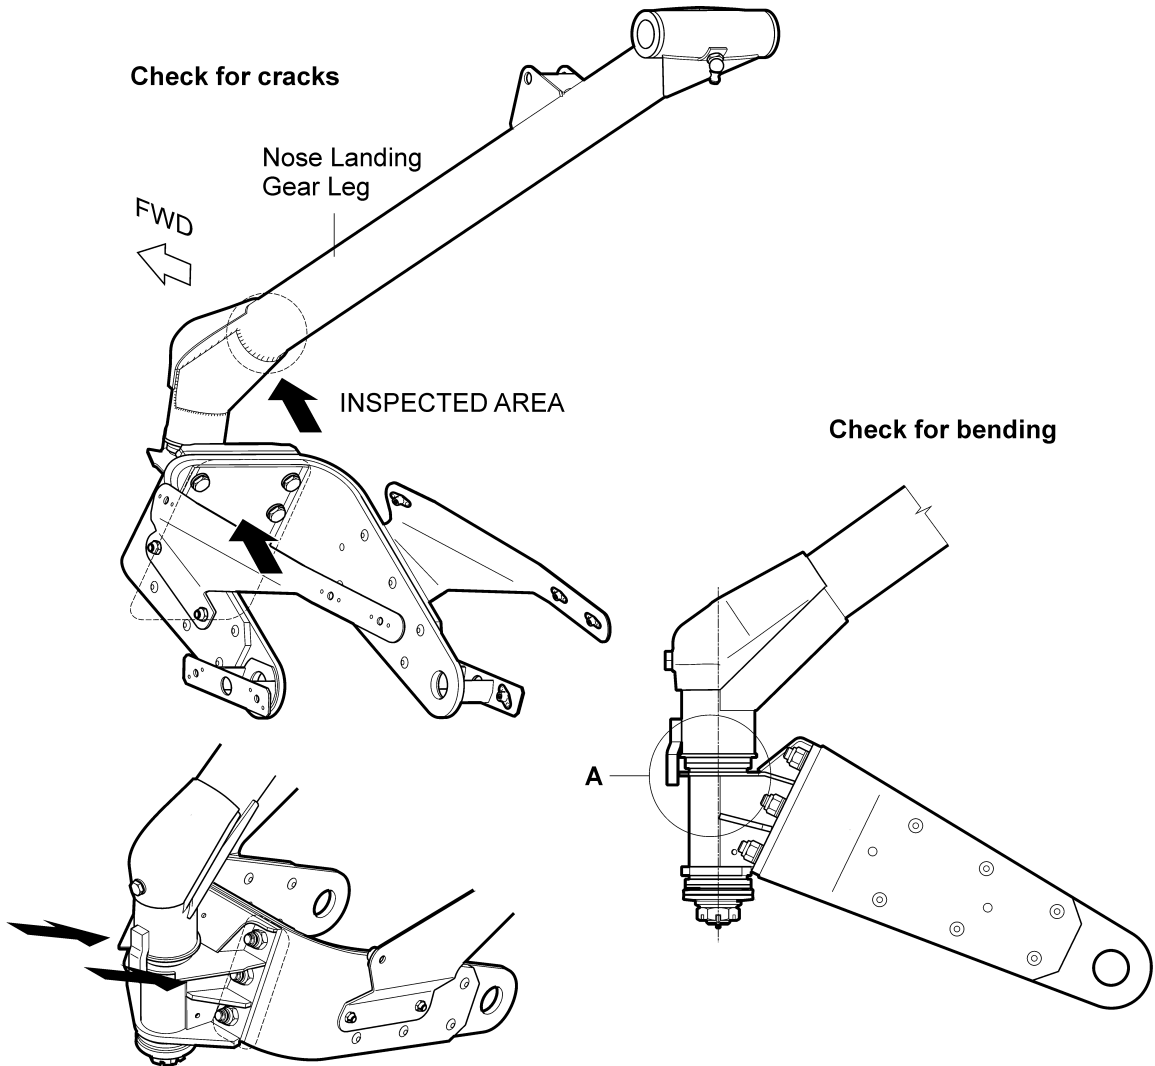
Some SportCruiser / PiperSport / PS-28 Cruiser aircraft have developed cracks in the bottom side of the lower section of the nose landing gear (NLG). The cracks develop on the NLG assembly along the weld of the tube and the bracket. Furthermore, on several aircraft bending of the pivot connecting the fork with leg was discovered and cracks from holes of bolts on the fork. To address this potentially unsafe condition, a repetitive inspection is required of the bottom side of the lower section, in the area of the weld of the tube, the bracket and the pivot and the fork in the place of the bolts mounting the fork to the landing gear.

- 2. Using flashlight and 10x magnifier, visually inspect nose landing gear leg lower section and verify there is no evidence of cracking in paint on or around the area of the weld of the tube and the bracket.

- 3. Using flashlight and 10x magnifier, visually inspect the fork in the area of the bolts mounting the fork to the landing gear and verify there is no evidence of cracking in paint.

- 4. Visually inspect pivot and verify there is no evidence of bending.
- E. If no cracking or pivot bending is evident, perform the following steps:
- 1. Nose wheel fairing will not be installed.

- G. In case of **confirmation** of cracking or pivot bending, perform the following steps:
- 1. Assure Aircraft on Ground (AOG).
 - 2. Report this occurrence to the manufacturer (CSA) within 72 hours.

- 3. Order from the manufacturer (CSA) NLG No. SG0300N.
 - 4. Install new nose landing gear NLG No. SG0300N according to bulletin SB-CR-021 or according to Chapter 8 of the relevant Maintenance Manual.
