Czech Sport Aircraft a.s.	<b>SERVICE BULLETIN</b>	Czech Sport Aircraft a.s. Na Záhonech 1177/212, 686 04 Kunovice Czech Republic office@czechsportaircraft.com
No. SB-SC-014		Rev.: -
Date: 2012-06-12		
Page: 1 of 3		Date: -

<b>MODEL AFFECTED:</b>	SportCruiser / PiperSport
<b>SUBJECT:</b>	Rudder fixed trim tab additional installation
<b>AIRCRAFT AFFECTED:</b>	All SportCruiser aircraft produced. All PiperSport aircraft produced. Aircraft serial numbers S/N P1102001 and subsequent will have the subject of this bulletin accomplished prior to delivery.
<b>COMPLIANCE:</b>	According to aircraft owner decision - depending on service conditions.

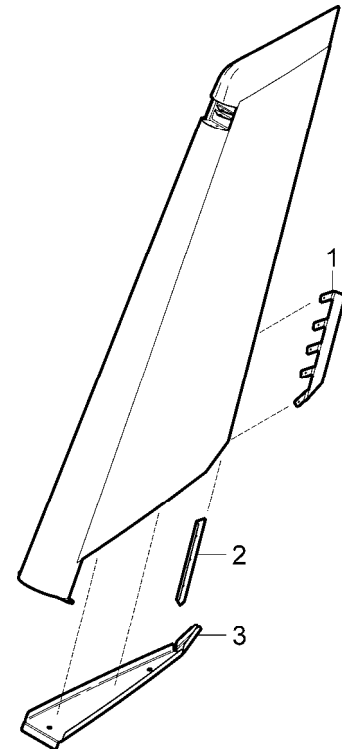
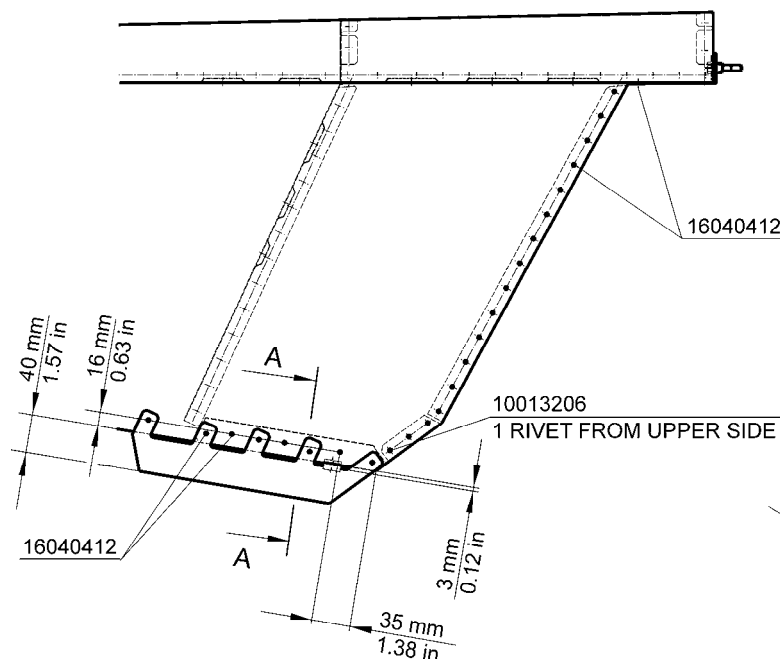
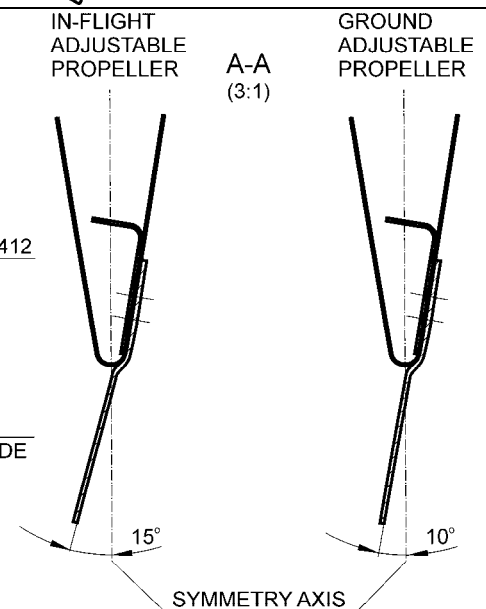
The Service Bulletin concerns an additional installation of the rudder fixed trim tab. The rudder trim tab may be added to relieve pedal pressure in cruise flight

1. Move the aircraft to a place suitable to perform the work.
2. Remove engine cowlings, disconnect positive battery terminal.
3. Remove rudder according instructions in the MIP or MM.
4. Carefully drill out the bottom rib (3).
5. Position the trim tab (1) as per figure, mark and drill off rivet holes using drill size 3.2 mm.
6. Position the reinforcement (2) on the holes for trim tab, mark and drill off rivet holes using drill size 3.2 mm.
7. Insert the reinforcement (2) to the rudder, position the trim tab (1) so that the rivet holes are aligned and parts mutually rivet.
8. Insert the bottom rib (3) to the rudder, position and rivet it. Use rivet type according figure.
9. Touch up coat on the rivets.

10. Set the tab to the initial angle according to type of installed propeller.
11. Install rudder according instructions in the MIP or MM.
11. Install engine cowlings.
12. Restore the aircraft to the airworthy condition.
13. Perform test flight; on the basis of test flight adjust final setting of the tab.
14. Update aircraft records to reflect compliance with this SB.
