Czech Sport Aircraft a.s.	<b>SERVICE BULLETIN</b>	Czech Sport Aircraft a.s. Na Záhonech 1177/212, 686 04 Kunovice Czech Republic office@czechsportaircraft.com
No. SB-SC-014		Rev.: -
Date: 2012-06-12		
Page: 1 of 3		Date: -

<b>MODEL AFFECTED:</b>	SportCruiser / PiperSport
<b>SUBJECT:</b>	Rudder fixed trim tab additional installation
<b>AIRCRAFT AFFECTED:</b>	All SportCruiser aircraft produced. All PiperSport aircraft produced. Aircraft serial numbers S/N P1102001 and subsequent will have the subject of this bulletin accomplished prior to delivery.
<b>COMPLIANCE:</b>	According to aircraft owner decision - depending on service conditions.

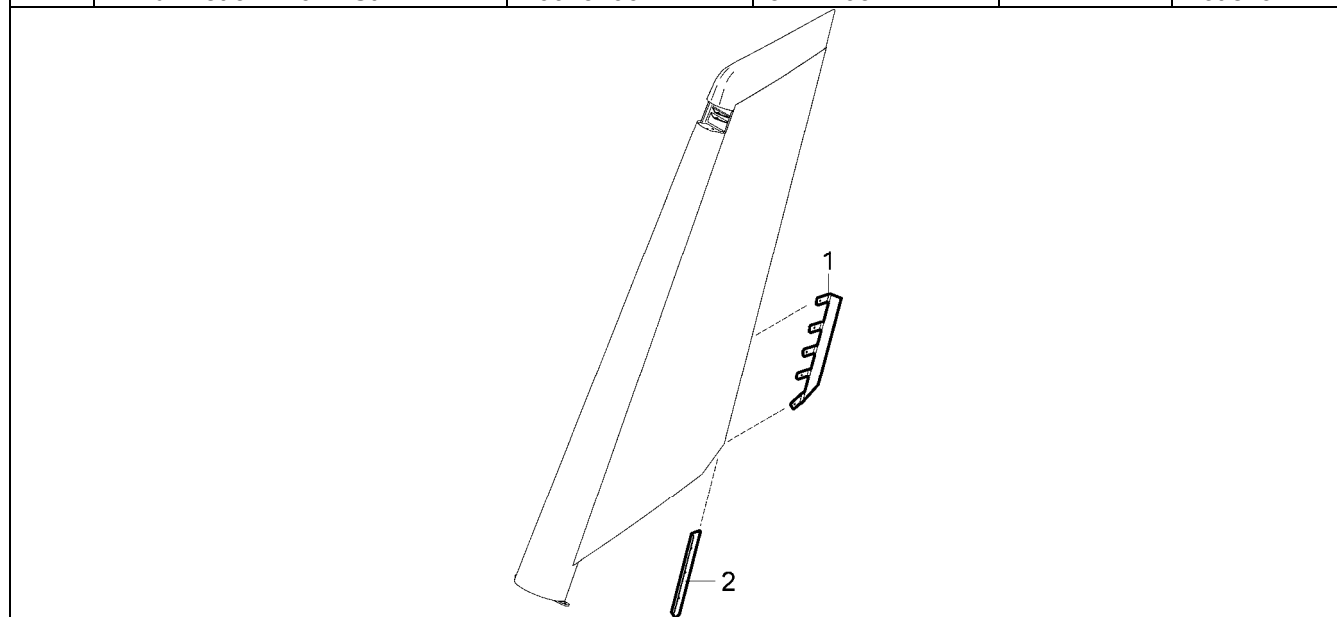
The Service Bulletin concerns an additional installation of the rudder fixed trim tab. The rudder trim tab may be added to relieve pedal pressure in cruise flight

10. Set the tab to the initial angle according to type of installed propeller.
11. Install rudder according instructions in the MIP or MM.
11. Install engine cowlings.
12. Restore the aircraft to the airworthy condition.
13. Perform test flight; on the basis of test flight adjust final setting of the tab.
14. Update aircraft records to reflect compliance with this SB.
