NO: SD-SC-006

SAFETY DIRECTIVE -MANDATORY-

MODEL AFFECTED:	SPORTCRUISER
SUBJECT:	FUEL CELL FINGER STRAINER – INCORRECT SEALANT USED
ASSEMBLED AIRCRAFTS AFFECTED:	07SC038 (OC4275), 07SC041 (OC4281), 07SC044 (OC4282), 07SC046 (OC4329), 07SC050 (OC4239), 07SC061 (OC4334), 07SC062 (OC4335), 07SC064 (OC700203), 07SC067 (OC4336), 07SC071 (OC4363), 07SC073 (OC4399), 07SC074 (OC3930), 07SC075 (OC3933), 07SC077 (OC700212), 07SC081 (OC4369), 07SC082 (OC700254), 07SC084 (OC3987), 07SC085 (OC3988), 07SC109 (OC3934), 08SC088 (OC700180), 08SC089 (OC4338), 08SC100 (OC700325), 08SC102 (OC700164), 08SC105 (OC700269), 08SC111 (OC700232), 08SC121 (OC4343), 08SC125 (OC700313), 08SC126 (OC700184), 08SC130 (OC4018), 08SC134 (OC700522), 08SC149 (OC700298), 08SC158 (OC4297), 08SC159 (OC700322), 08SC170 (OC700491), 08SC172 (OC700299)
KITS AFFECTED:	07SC037QBK (OC4074), 07SC048QBK (OC3837), 07SC049QBK (OC3855), 07SC057QBK (OC3857), 07SC092QBK (OC3853), 07SC097QBK (OC3945), 08SC108QBK (OC4007), 08SC113QBK (OC4010), 08SC120QBK (OC4012), 08SC122QBK (OC4311), 08SC127QBK (OC4006), 08SC138QBK (OC4041), 08SC145QBK (OC4027), 08SC151QBK (OC700466), 08SC153QBK (OC4188), 08SC154QBK (OC4131), 08SC165QBK, 08SC166QBK,

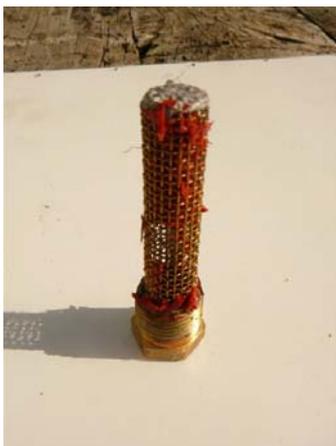
Picture 1 – finger strainer

Application of incorrect sealant of fuel cell outlet was found out (See picture 1,2). Used sealant is not intended to permanent contact with gasoline and may degrade. It can cause fuel leaks, corruption of fuel flow meter, blockage of finger strainer or gascolator screen, low fuel pressure and at the worst case engine stop. Was found out that it may occur in aircraft S/N defined above.

1. Remove inspection cover in wing bottom area close to wing root, both wings. (Picture 3)
2. Check color of sealant that could be visible around the thread of finger strainer and fuel fitting. If it is white (light gray), then the SD is done. Install inspection covers and annotate aircraft records to reflect compliance with this safety directive.
3. If the sealant is red (orange,brown), or there is not visible sealant, or there is uncertainty about sealant color, continue to **Step 2**.

1. Ground aircraft.
2. Remove engine cowlings.
3. Disconnect battery.
4. Drain fuel system, open fuel caps and let vapor ventilate.
5. Disconnect fuel hose from fuel outlet brass fitting (Picture 4).

6. Remove brass fitting and finger strainer from fuel cell, disconnect brass fitting and finger strainer (Picture 5).
7. Remove drain valve from fuel cell.

8. Carefully clean sealant from brass fittings, finger strainers and fuel cell.
9. Rinse fuel cell by gasoline to clear debris away and let it dry. If necessary, clean debris by vacuum cleaner.

13. Degrease threads of fuel cells, finger strainers, brass fittings and drain vents by cleaning solvent.
14. Apply a 360° bead of sealant (LOCTITE 565) to the leading threads of the male fitting, leaving the first thread free (Picture 7). Force the material into the threads to thoroughly fill the voids. Using accepted trade practices, assemble and wrench tighten fittings until proper alignment is obtained. Allow the sealant to cure a minimum of 24 hours.
